## PIX BROOK WATERCOURSES PROJECT PROJECT OUTLINE

### THE PROJECT

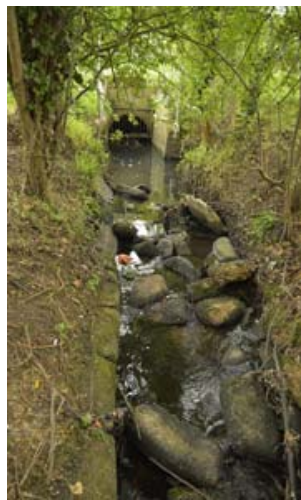
Shaded watercourse blocked with concrete

- heavily shaded with vegetation
- have steep banks
- have blockages in the channels and
- outdated concrete structures all contributing to erosion and leading to localised flooding.

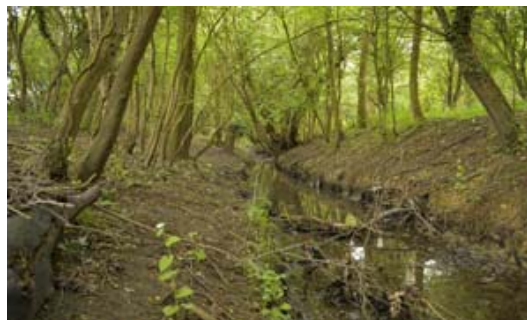
Shaded watercourse

Tree works will be carried out along the watercourses to increase the light to the channels helping plants to establish.

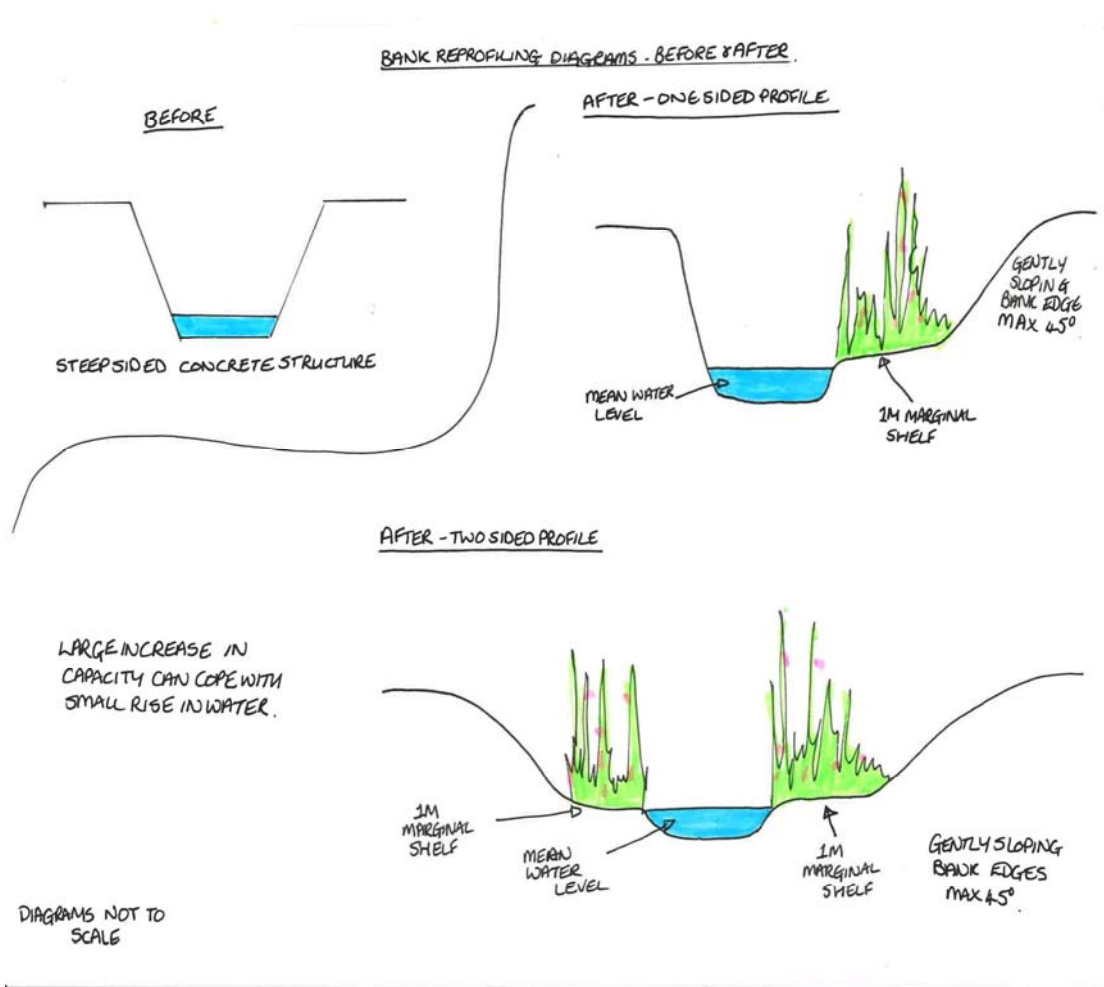
- Creating marginal shelves to give the channels greater capacity in times of high flow
  - The channel edges will also be reprofiled to give gently sloping banks and wetland plants will be planted on the shelves to help speed up establishment

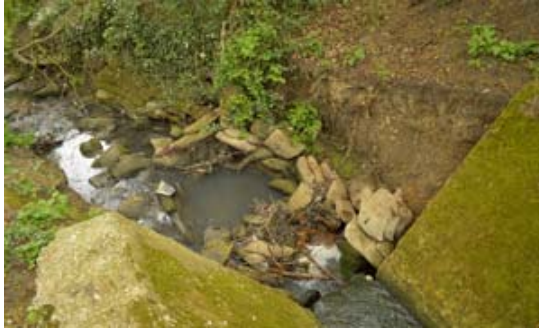
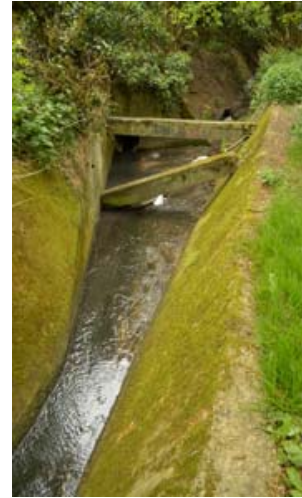
Concrete structure in disrepair

- Removing outdated structures
  - Old outdated structures are becoming eroded, these will be removed, the channel reinforced and banks reprofiled
