Butt's Close Pond, Hitchin

Project detail

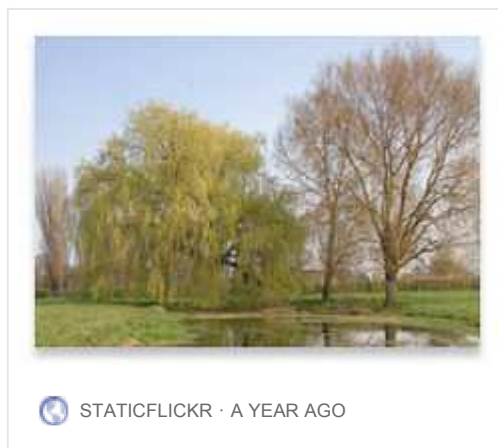
Trees needed to be managed to reduce the amount of shade they cast, cut down on the number of leaves that fell into the pond and allow people to see it.

Two large willows were pollarded; a traditional management technique where branches are cut back severely and allowed to re-grow from the cut ends. This reduces the size and weight of the crown of the tree.

The prominent weeping willow was treated less aggressively. The crown was gently reduced and re-balanced to create a pleasing shape whilst reducing shade cast and improving access to manage the ground beneath.

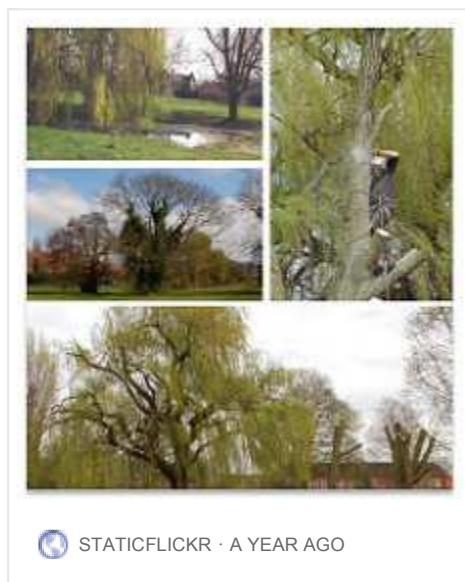
Above, clockwise from left: Trees shading pond before, First cut of the willow, Trees after the cut, Trees before

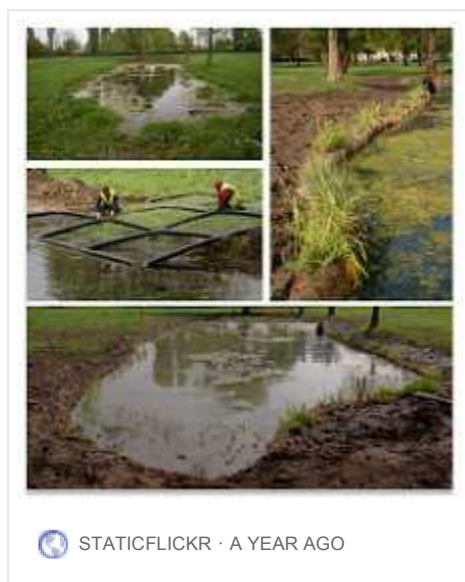
The pond had a number of problems. The banks were steep and edged with concrete gabions and slabs, meaning that few plants could grow. The water suffered from large algal blooms - these are a sign of high nutrient levels entering the water.

Above, clockwise from left: Pond before, Installing the bioroll, Pond after, Building the reed bed

Shallow marginal areas were created and planted with colourful native species such as water mint, marsh marigold and ragged robin. Where the banks are at their steepest Coir (coconut fibre) bio rolls planted with rushes, sedges, reeds and flag iris were installed.

A floating reed bed was constructed from an interlinked tubular framework and installed close to the water inlet. This was covered by a thick mat of coir pillows planted with common reed and anchored to the pond base. This hydroponic reed bed will suck unwanted nutrients from the water reducing algal blooms. When established it will be 50% more efficient than a traditionally planted bed.

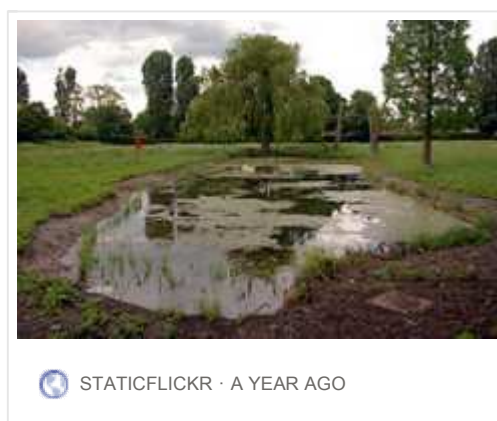
Pond plants are beginning to settle in and the surrounding meadow recovers from the disturbance.

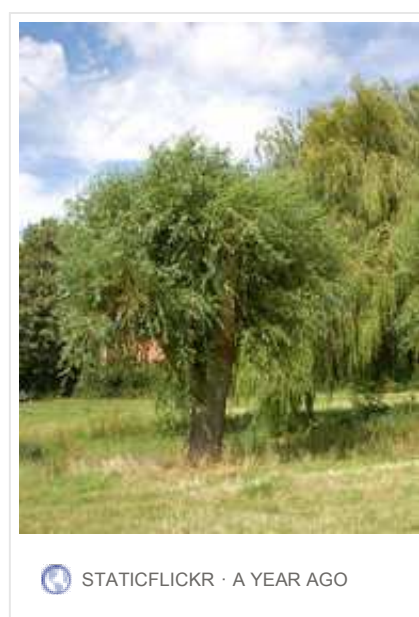
High summer and all of the bare earth has been reclaimed by surrounding vegetation and the pollarded willow trees are now covered in vigorous new growth. The first seasons growth is now in full bloom, emergent plants such as purple loostrife are flourishing.

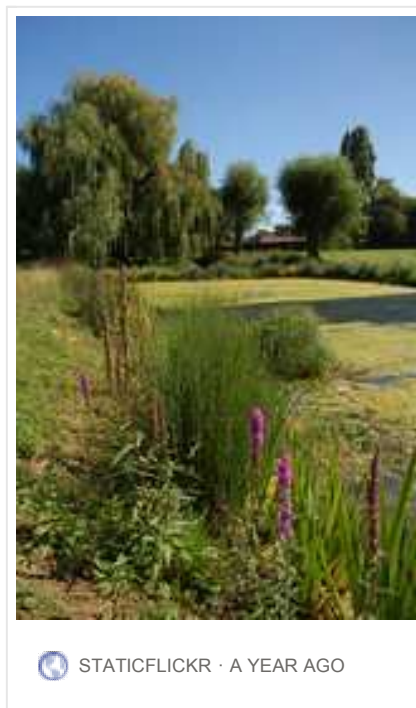
As the pond enters its second season all of the pond plants are now fully established and ready for the warmer weather of spring. Happy frogs can be seen enjoying the pond and laying their spawn.

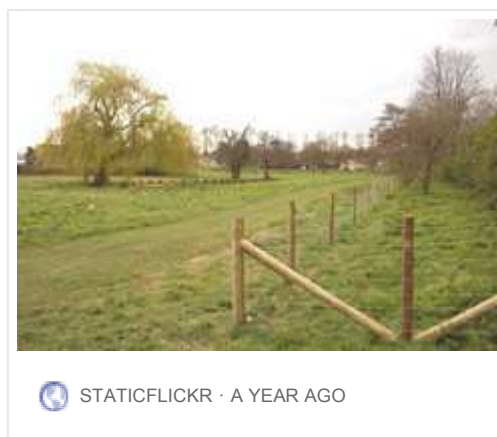
The final part of the project is now in place as the protective fence around the native shrub planting is completed.
